SHEET NO.12 14 SHEETS

TE I	160	CRETE REPA D OVER U.S. N. 014-0065			
F.A.P. RTE.	SECTION					COUNTY	TOTAL SHEETS		SHEET NO.	
690 14-12BR-1					CLINTON	72		32		
					CONTRACT	NO.	76	B27		
 FED. RO	DAD DI	ST.	NO	ILLINOIS	FED.	ΑI	D PROJECT

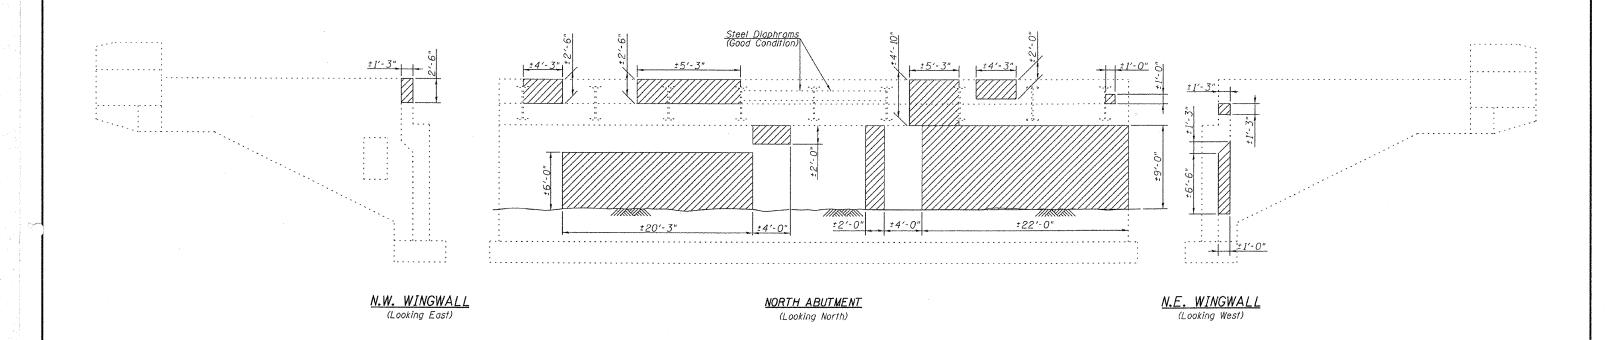
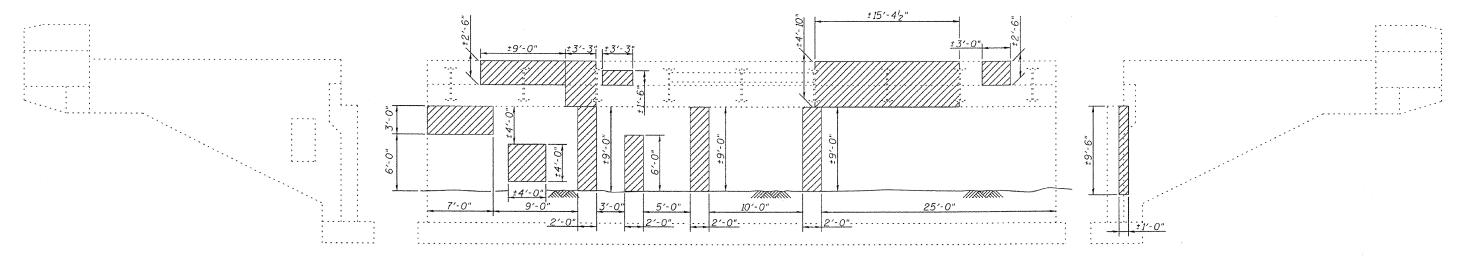
S.E. WINGWALL (Looking West)

SOUTH ABUTMENT (Looking South)

S.W. WINGWALL (Looking East)

Notes: Hatched area indicates approximate area of Structural Repair of Concrete. Exact repairs are to be determined by the Engineer.

All existing abutment seats shall be cleaned & sealed. Work will be paid for as Cleaning Bridge Seats.
